RE: Chemical Analysis of Crumb Rubber Samples-Electron Dam Site  
Case Name: Electron Hydro LLC; [10906767]

## Summary of Findings

## **Draft Sampling Plan: February 26, 2021 (updated Feb 3, 2022)**

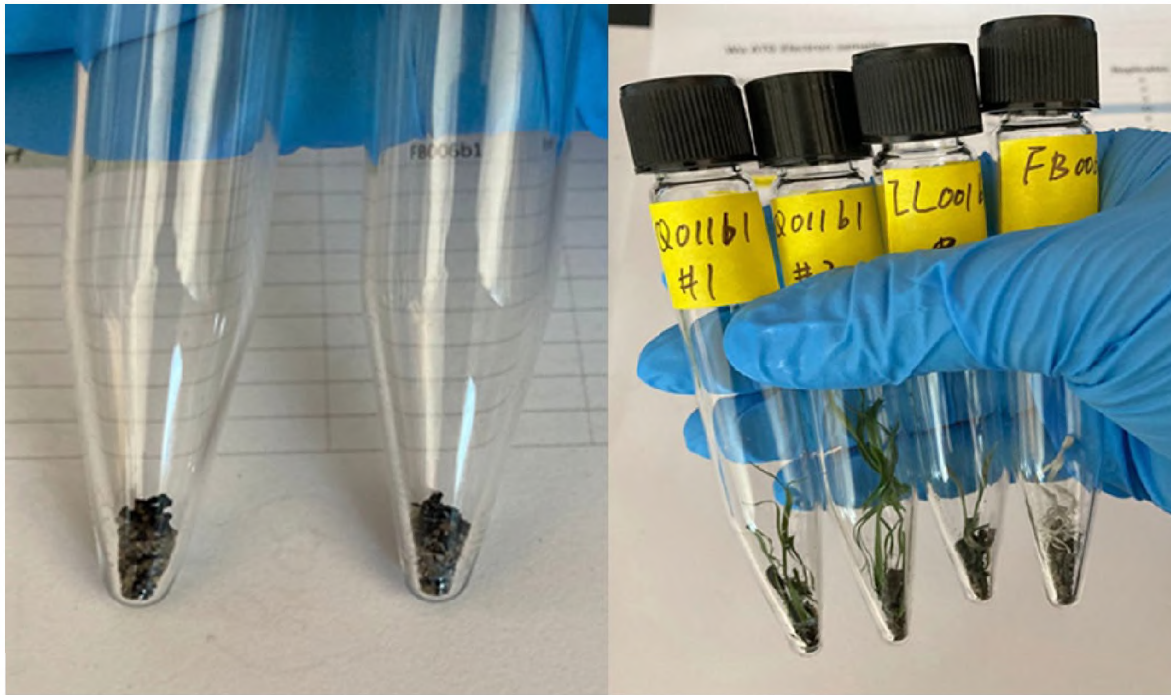
**Figure 1:** Crumb rubber infill sample (left) showing mixture of crumb rubber and fine sand. On right, turf sample showing mixture of artificial grass, rubberized sublayer, and mixed crumb rubber that was subsequently solvent extracted and analyzed.

Crumb rubber infill materials contained fine quartz type sands for drainage and volume purposes in addition to the rubber grains (Figure 1). Provided turf materials also had some residual crumb rubbers and sand enmeshed in the rubberized woven sublayer and artificial grass material. Much of the “turf” sample (by composition) was comprised of the stiff, rubberized woven sublayer material. This sublayer supported the overlaying artificial grass and infill materials (Figure 2). Typically, it was difficult to fully remove the residual crumb rubbers from the turf sublayers, the grass and woven materials easily trapped crumb rubber infill materials. While Figure 1 demonstrates what was extracted for analysis, Figure 2 also demonstrates the residual crumb rubber and sand materials that could be shaken out of the turf samples upon handling and shaking.
